Drainage Rehabilitation with Point-Lining, Parramatta Rd, NSW

Project Details

Industry: Storm Water, Under Road
Project: Parramatta Rd, Camperdown
Application: Robotics & Point-lining

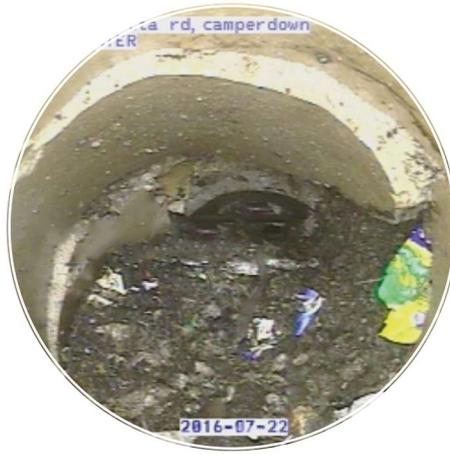
BEFORE

Ventia Boral Amey Joint Venture (VBAJV) engaged ITS PipeTech to undertake investigation works and drainage rehabilitation to the intersection of Parramatta Road and Missenden Road, Camperdown. During the CCTV inspection and cleaning, it was discovered that the drainage capacity was not as expected due to age of the asset. Many irregularities were discovered in the layout of the drainage network and several major defects were putting the functionality of the network in jeopardy and in risk of imminent failure.

Specialist teams from ITS undertook the repair using state of the art robotic grinding, high pressure water jetting before installing a 1200mm long class IV point-liner install which completely bridged the void and returned the pipeline to full functionality. Once the repair had been completed, ITS crews were then able to continue the CCTV inspection to determine where this asset connected and where it played a part in the intersections drainage.

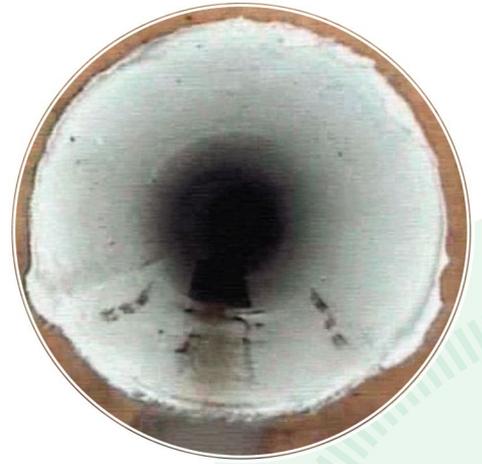
AFTER

The works were successfully completed without having to excavate, resulting in no disruption to local traffic, minimizing the cost and providing a further 50 years functionality on the existing asset.
