To ensure sports fans aren't inconvenienced SOPA choose ITS PipeTech

Project Details

Client: Sydney Olympic Park Authority (SOPA)

Project: Remediation of the storm water drainage system serving the SOPA

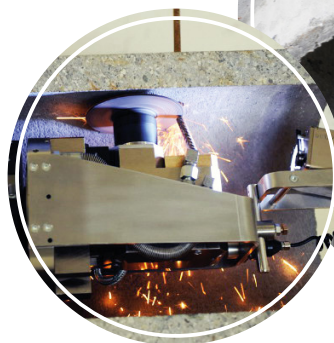
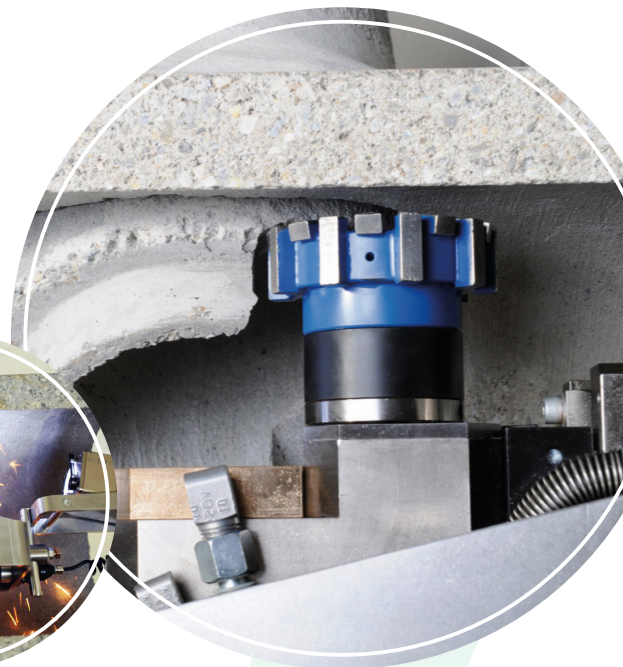
SOPA was concerned that soil would infiltrate the storm water drains through the fractures that had been detected, all of which extended right through the walls of the pipe and in some cases exceeded 25mm in width. Pipe lifting holes that were not plugged and posed a risk of soil ingress. Defective cut-ins had exposed reinforcing steel that needed to be protected.

ITS PipeTech pipeline robotics unit was used to prepare and complete full structural repairs on the defects. Three repair methodologies were used:

1. Man entry for greater than 800mm diameter pipe using cementitious and epoxy repair material
2. Robot applied epoxy injection for sealing of junctions and pipe defects
3. Point-Lining® for the repair of cracks, fragmentation, leakage, broken joints, capping off disused junctions, defective liner installations and corrosion.
